STRUCTURAL ENGINEER'S REPORT ON

THE ENGINEERING PROGRESS AT MENOKIN

26 March 2010

Menokin Project Engineering Report

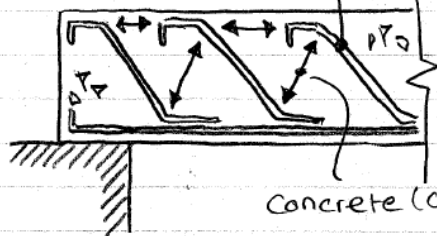
Reinforced Concrete Analogy:

typical failure plane due to low tensile capacity.

Bent-up bars. (tension)
Concrete (compression)

Bent-up bar reinforced Concrete Solⁿ... Action Similar to a truss:

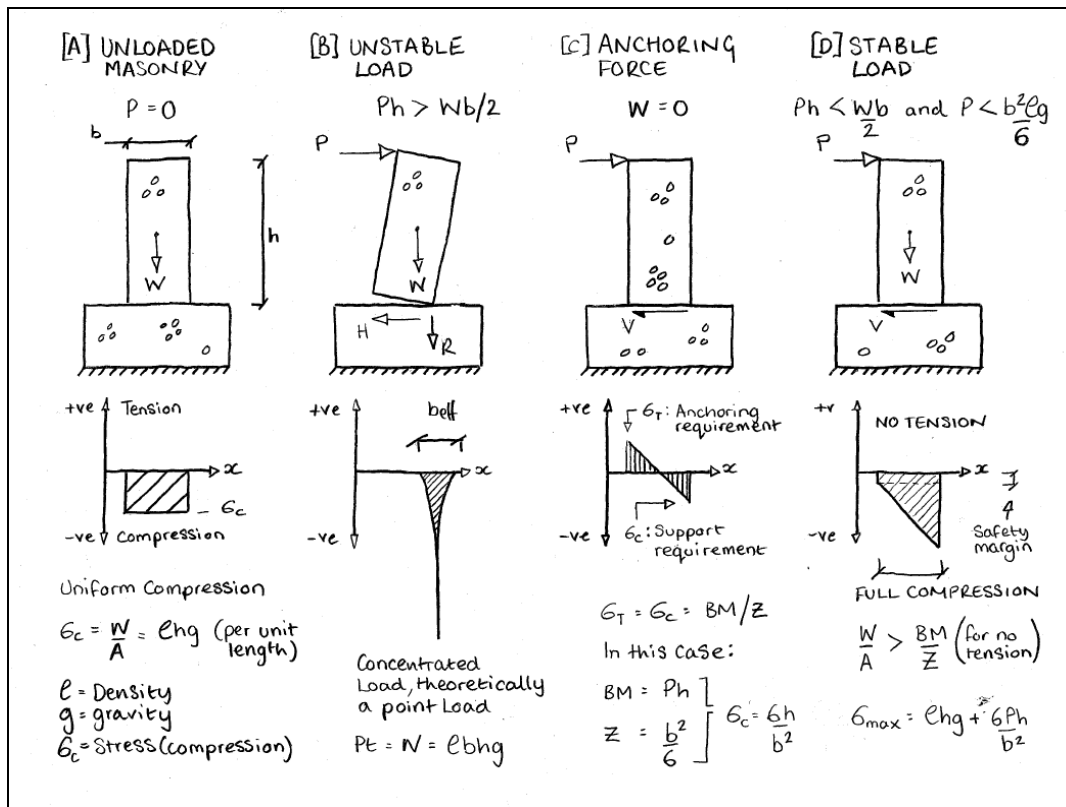
Forces that lift the masonry out of the mortar redistribute the load into concentrated areas. The lime will start to re-carbonate and the mortar starts to crumble. Soon the bricks start bearing on each other with intense loads, grinding away with ever increasing load cycles that intensify according to the decreasing stability of the entire wall. The overall stability of the wall depends on the applied bending moment being less than the stabilising moment. The applied bending moment is a function of destabilising force and the applied leverage. The stability of the element depends on its mass and the position of the centre of gravity.

Unfortunately it is difficult to get reliable information about the stability of a wall, because you can't accurately determine the internal structure. Assumptions can be made and when they are, it is a straight forward task to determine the stability and work out how much additional mass is required to prevent the wall from deteriorating any further. However, the answers are only as accurate as the information used to generate them.

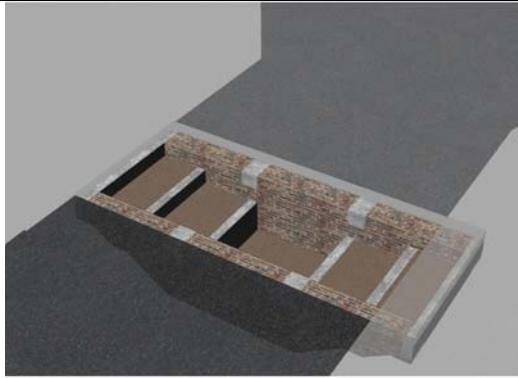
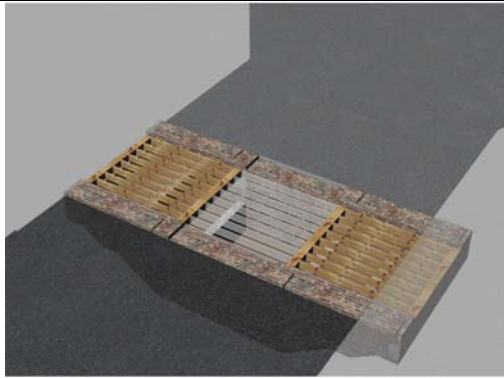
[A] Foundations + Retaining Walls	[B] Suspended Floor Arrangement

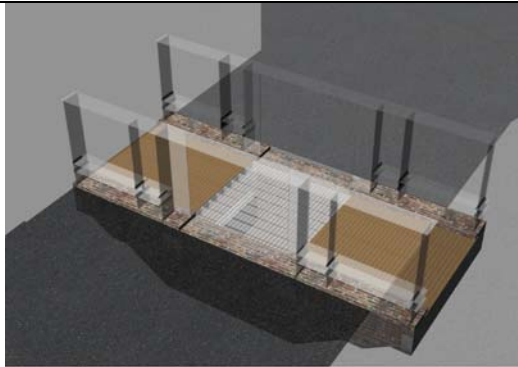
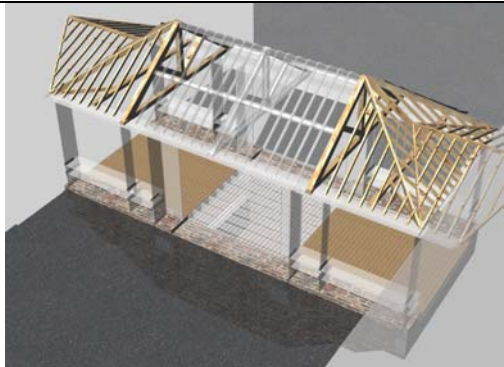
[C] Fins and Shelves	[D] Roof Framing

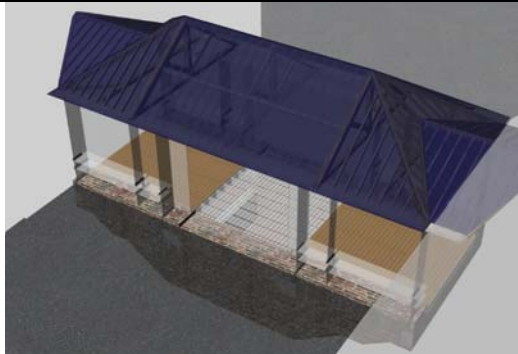
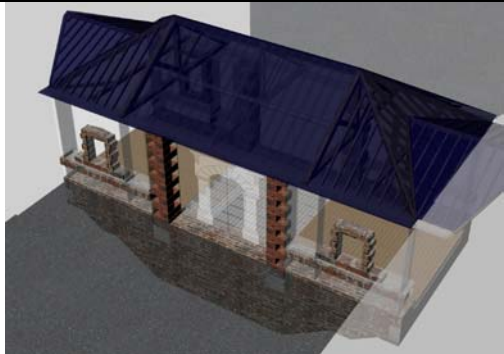
[E] Roof Panels	[F] Historic Masonry

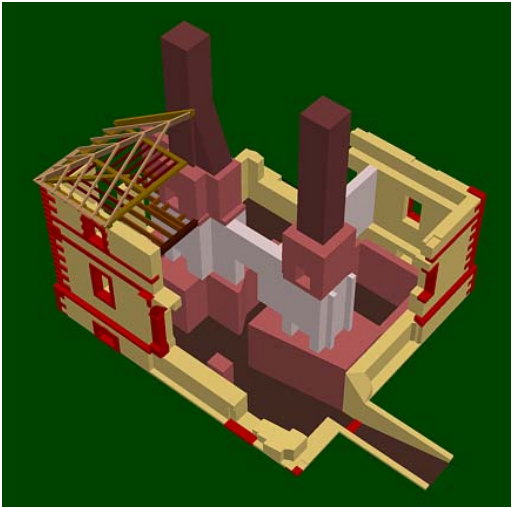
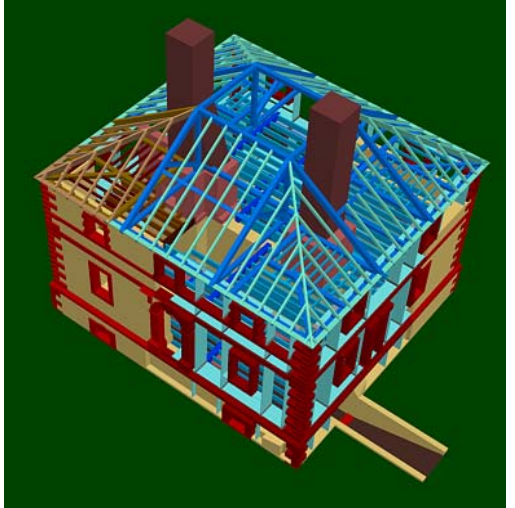
The geometry model was created by Ed Lowe. This was then sent to Future Realities, a graphic design company which applied material textures taken from many photos of the buildings. The illustrative images and the promotional renders are a product of Future Realities.

<p><i>Geometry Model – Existing Structure</i></p>	<p><i>Geometry Model – Proposed Structure</i></p>
